AESTIMO, INC.

August 13, 2024

Subject: **Review of Steeple Distress and Water Infiltration**
St. Andrew Catholic Church
827 Sheldon Road
Channelview, TX 77530-3511
Aestimo Project No. 245286-01

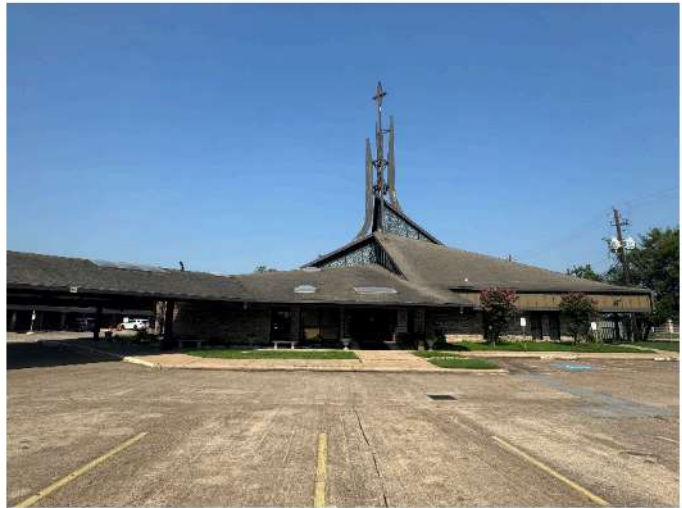
1. Overview of the east elevation of St. Andrew's sanctuary. Note that delaminated paint is apparent on the vertical column members of the steeple. In addition, reported water infiltration within the sanctuary appears to be limited to areas directly below the clerestory windows along the stepped roof line.

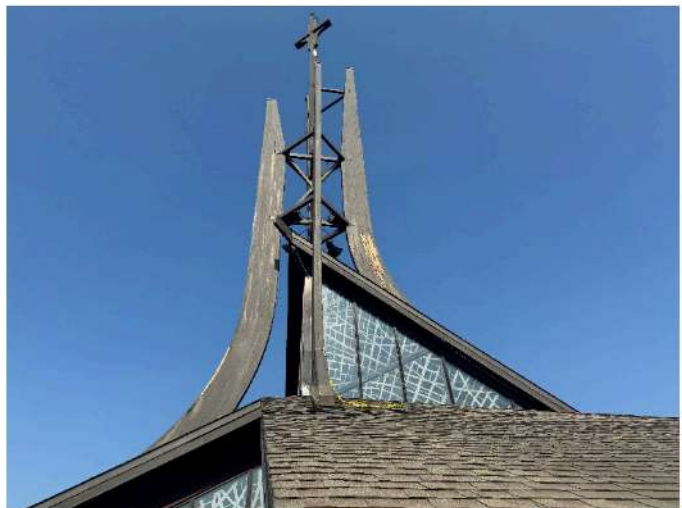
2. Photograph of the east side of the sanctuary steeple. The attachment of the four arched columns of the steeple assembly to the roof structure could not be determined. Note areas with delaminated/missing paint. Also note that wood decay is apparent within localized areas of the arched column members.

1. Install scaffolding for access to the steeple. Remove upon completion of the repairs.
2. Remove existing sheet metal flashings at the bases of the steeple as well as at the tops of the exposed wood surfaces. Replace sheet metal flashings when repairs are complete.
3. Remove all paint from the glue-laminated wood, exposing the surface of the wood.
4. Using mechanical or other means, remove all deteriorated/rotten wood and replace it with an epoxy-based wood filler. If necessary, splice in new wood sections on an "as-needed" basis.

5. Spread epoxy-based wood filler over the surface of grooved or uneven wood surfaces and sand to a smooth finish.
6. Evaluate the condition of the anchorage of the arched columns to the roof structure. If necessary, install steel reinforcement plates to properly anchor the steeple assembly.
7. Replace deteriorated wood rakes/fascias or remove and replace deteriorated wood sections with epoxy wood filler.
8. Replace deteriorated sections of the wood ridge beam at the peak of the high-slope roof as well as the rakes/fascias or remove and replace deteriorated areas with an epoxy wood filler.
9. Apply new paint/coating on the wood and steel components to provide long-term protection against weathering.

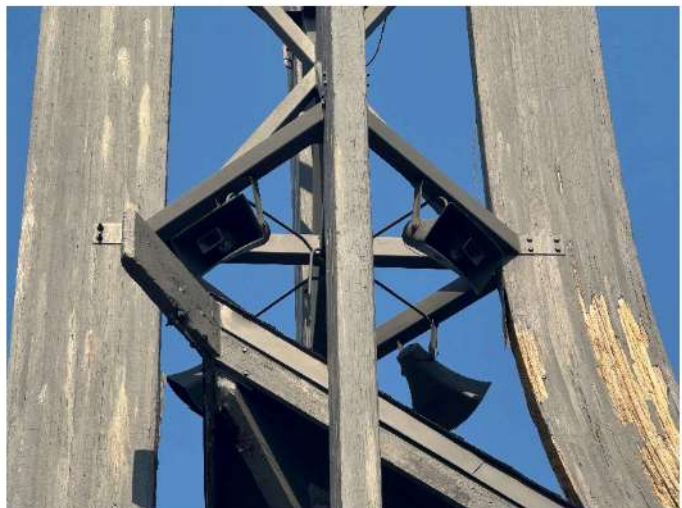
3. Close-up view of the arched steeple columns. Note the missing paint and apparent minor decay of the underlying glue-laminated member.

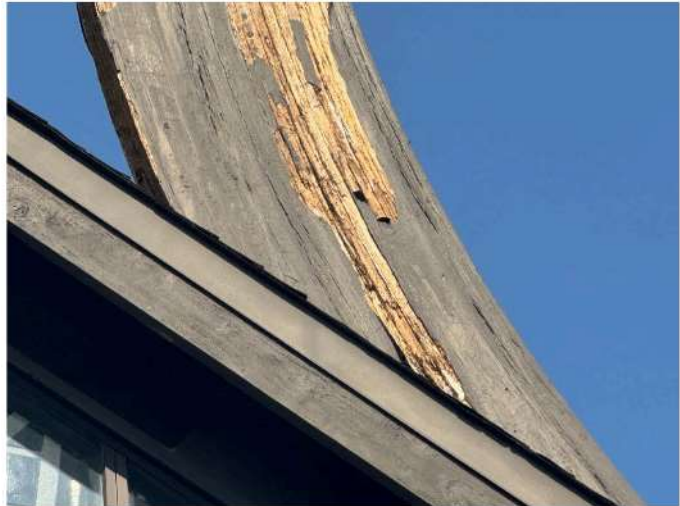
4. Close-up view of water-related deterioration at the base of the north arched steeple column. Similar distress is also apparent on the other three other columns, particularly the one on the west side.

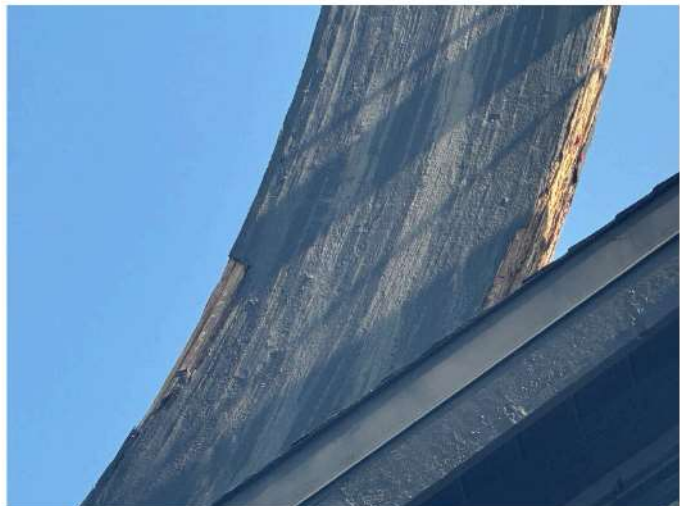
5. View of the base of the south arched column member of the steeple. Rotten wood is apparent at the corners of the member; however, the interior wood generally appears to be in acceptable condition.

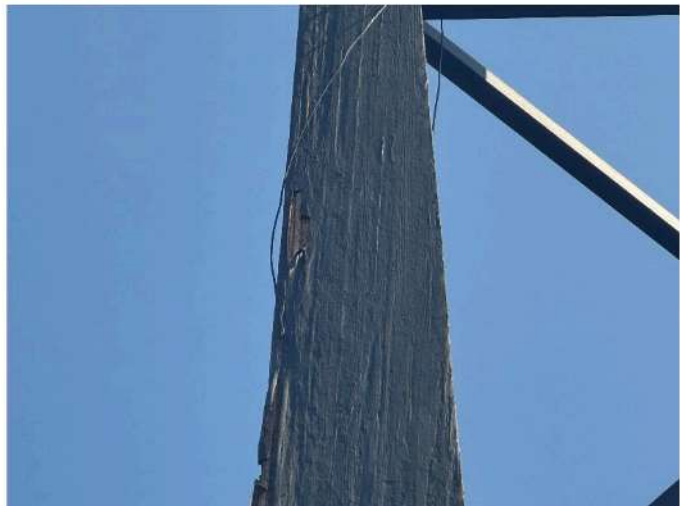
6. In general, the arched steeple columns exhibit uneven surfaces, which have been coated with paint. Most of the more significant deterioration is evident at the corners of the members.

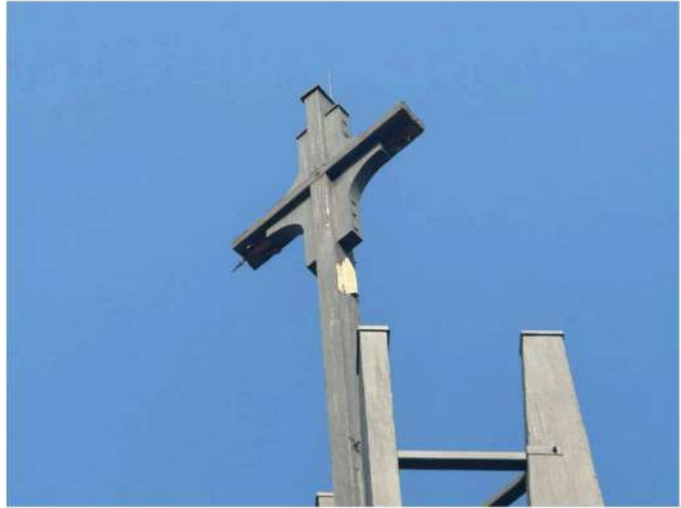
7. Delaminated paint and localized wood decay is apparent on the top of the cross member as well as immediately below the cross at the top of the steeple. Note that sheet metal caps have been installed at the tops of vertical glue-laminated members. This flashing appears to have minimized deterioration of the protected members.

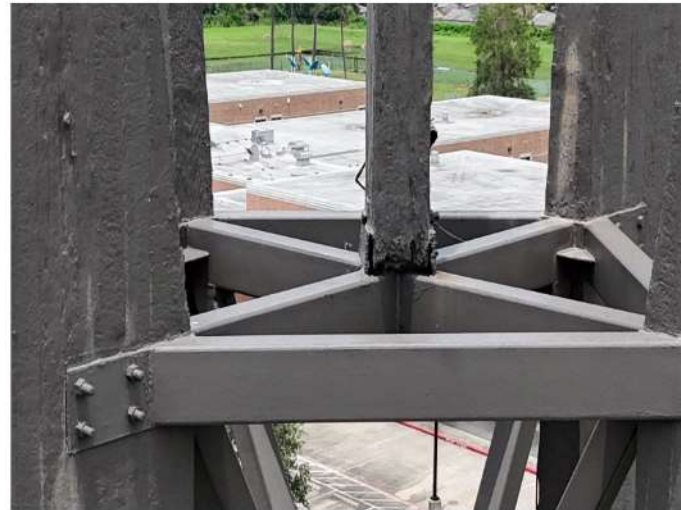
8. Steel framing members tie vertical members of the steeple together (photograph provided by St. Andrews). The steel members and bolted connections appear to be in good condition. It should be noted; however, that the base of the center vertical member of the cross exhibits deterioration. The extent and severity of the deterioration was not apparent from the vantage point of the photographer. Close-up inspection will be required to determine appropriate corrective action.

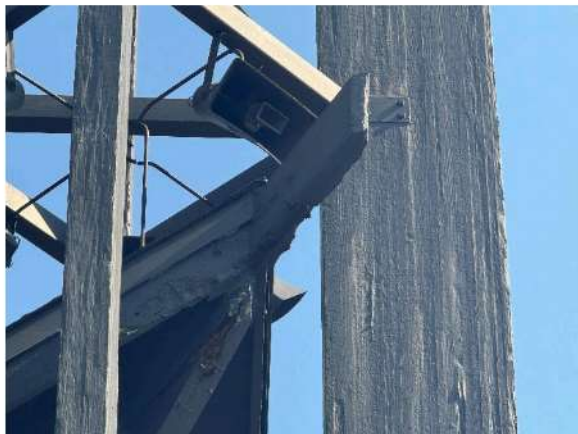
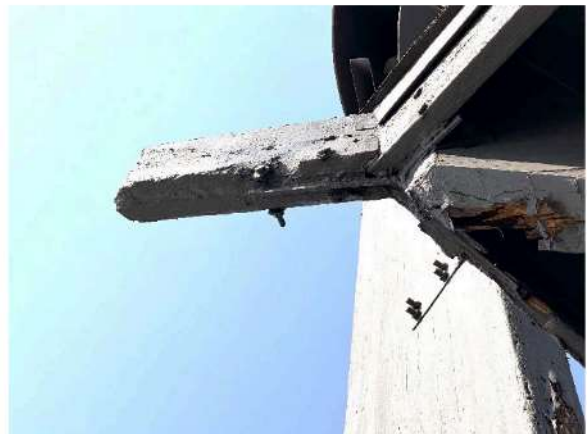
9. The ridge beam extending out from the southeast corner of the upper roof and the rake/fascia that frames into the ridge beam exhibit severe deterioration. The photograph below on the left was documented from the southwest and the one on the right was documented from the east, looking upward.

7. Replace deteriorated wood rakes/fascias or remove and replace deteriorated wood sections with epoxy wood filler.
8. Remove and replace or install new silicone sealant at all joints in clerestory rise walls.

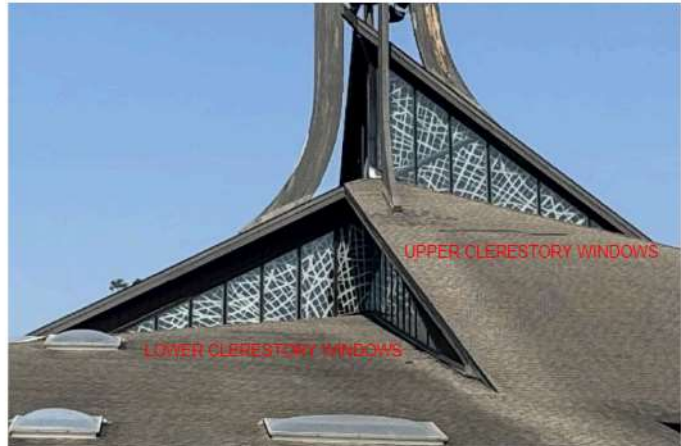
10. Clerestory windows are provided within the roof structure of the sanctuary. The lower clerestory windows are located at the step between the low-slope and mid-slope roof area within the southeast corner of the sanctuary. The upper clerestory windows are located at the step between the mid-slope and high-slope roof areas within the northwest corner of the sanctuary. The windows are constructed with Dalle de verre-type stained glass set in wood or aluminum frames with perimeter sealant. Protective glass is provided on the outside of the original window frames using aluminum frames and perimeter gaskets.

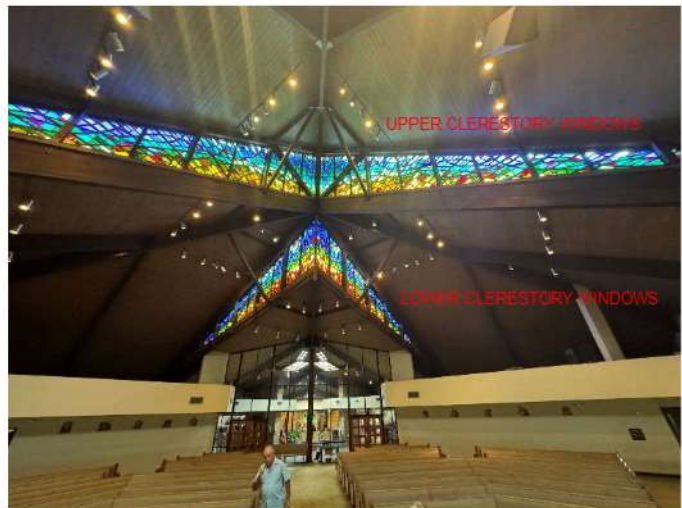
11. View of the stained glass clerestory windows from the interior of the sanctuary, looking toward the southeast. Note that water infiltration was reported to occur directly below the glue-laminated beams that extend below both the lower and upper clerestory windows.

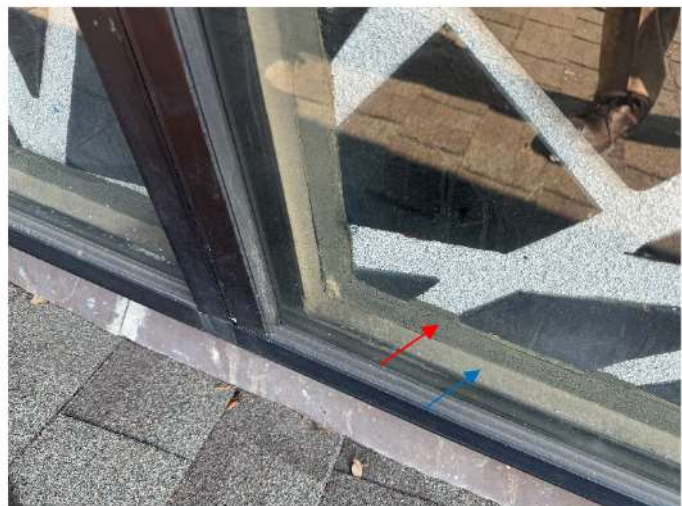
12. The sealants for the stained glass appeared to be in fair condition with normal crazing of the surface as a result of aging (red arrow). Localized adhesive failures were observed at isolated locations. A second sealant joint is apparent between the aluminum frame for the protective glass and the original window frame (blue arrow). This sealant also exhibits crazing. The purpose of the sealant appears to be to seal the back side of the protective glass frame.

1. Remove existing protective glass from window frames and temporarily store them on site.
2. Remove existing sealant from underlying stained-glass perimeters as well as the sealant between the stained-glass frame and protective glass frame. Ensure that original sealant is completely removed and replace sealant in both locations with new silicone-based sealant.

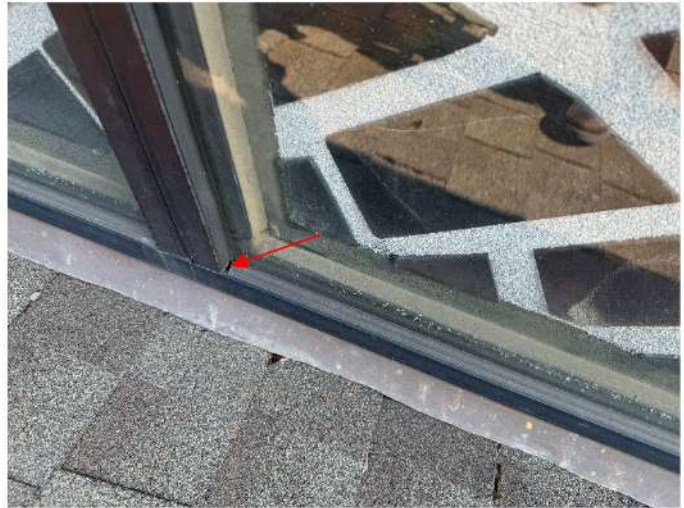
13. Gaskets for the protective glass were observed to be in fair condition; however, shrinkage has resulted in gaps forming at the window corners.

3. Clean the inside and outside faces of the stained glass.
4. Clean the inside and outside faces of protective glass and reinstall in existing aluminum frames using new gaskets or silicone “wet sealant” (cove bead of sealant between glass and frame).

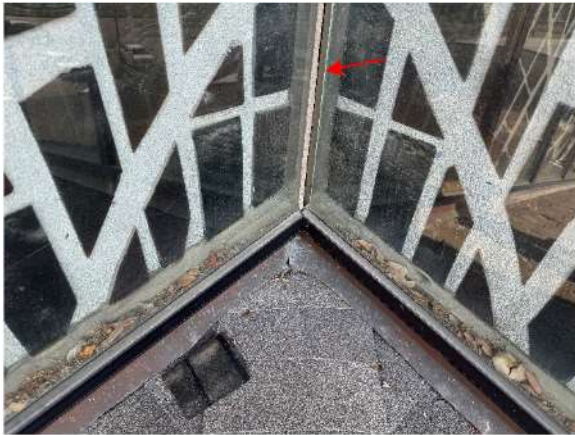
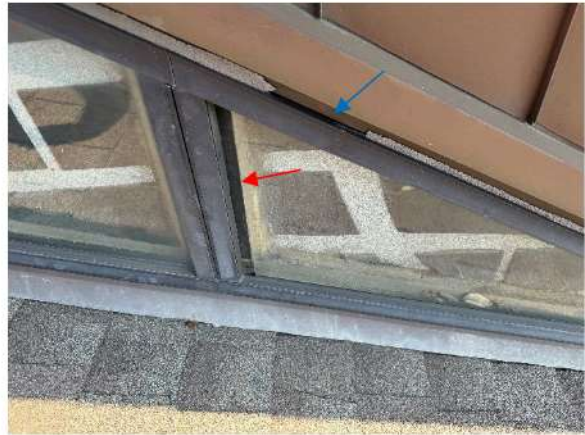
14. The protective glass was observed to have shifted at two locations, providing gaps through which storm water, as well as leaves and other debris can enter the window system (red arrows). Also note that protective glass window sealant around the perimeter of the windows is generally in a deteriorated condition and is missing at isolated locations (blue arrow).

5. Remove and replace window frame perimeter sealants with silicone sealant.
6. Remove and replace or install new “band-aid” type silicone sealant over existing joints in the aluminum window frame.

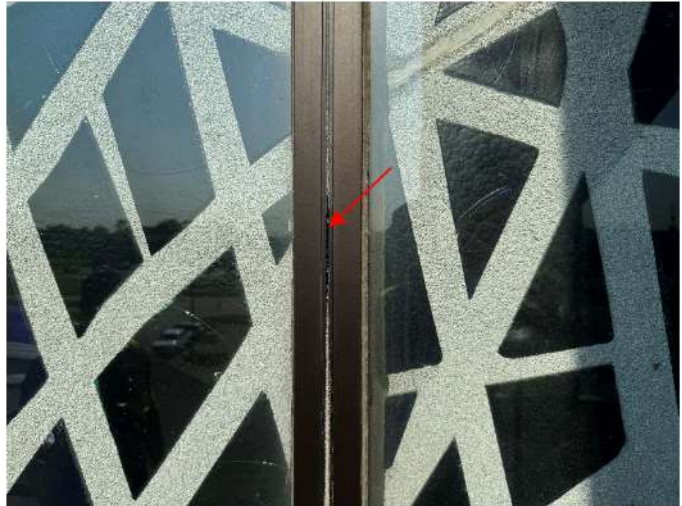
15. Sealant was applied to the joints of some lower clerestory windows; however, the sealant is exhibiting deterioration due to normal aging and is missing at isolated areas. Typically, no sealant is provided in these joints on the upper clerestory windows.

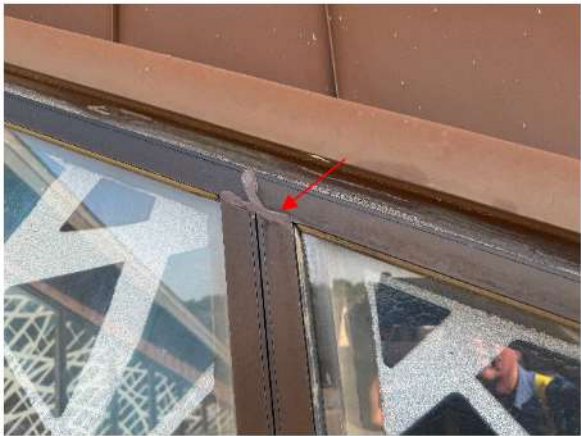
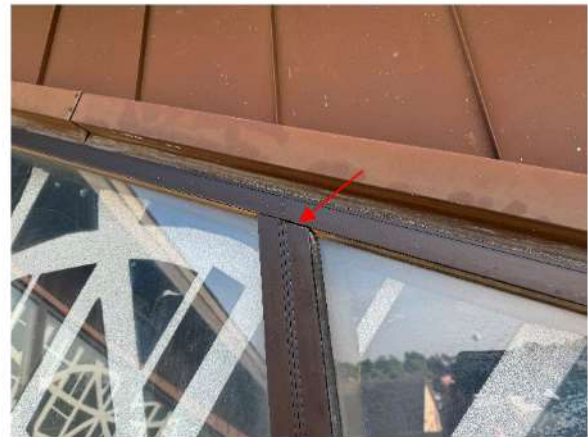
16. Sealant has been remedially applied over some, but not all joints in the protective glass aluminum frames.

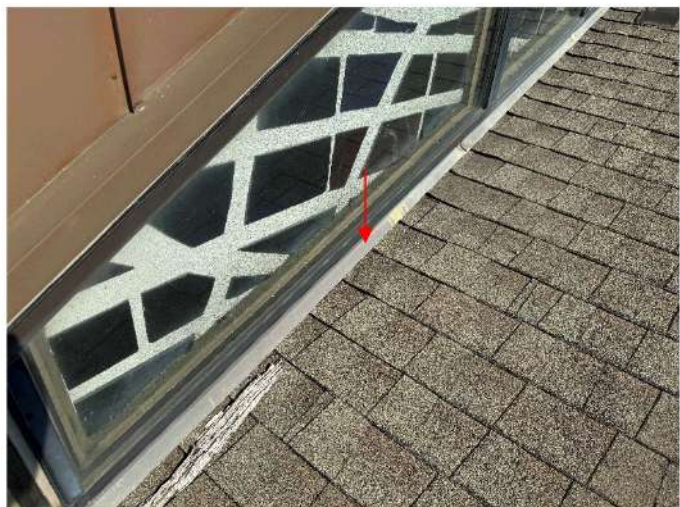
17. Sheetmetal rise-wall flashings are installed below the protective glass frame. It could not be determined whether any leaks could be related to deficiencies in the flashing without excavations; therefore, this remains a possible contributing source of water infiltration to the building interior.

To address water infiltration within the sanctuary, AESTIMO recommends replacing the deteriorated sealants on the clerestory windows and rise walls of the sanctuary. It is likely that the existing water infiltration is limited to the existing defects in these systems; however, it is also possible that infiltration is occurring at the transition between the shingle roof and the base flashing below the clerestory windows. If addressing the window and rise-wall sealants is not entirely successful in eliminating the current leaks, replacement of the base flashing may be necessary; however, replacement is not recommended at this time.

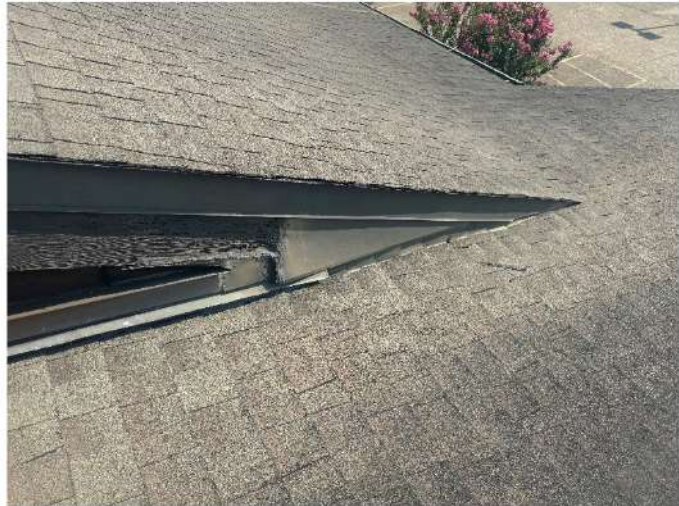
18. Flashing is provided at the transitions between the various roof levels and sealant is utilized to seal the flashing to the substrate. The sealants are typically in a deteriorated condition due to normal aging. In addition, deterioration of the wood rakes is apparent at the flashing locations.
